**CONTINUING ELIGIBILITY INSPECTION (CEI) REPORT**  
**FOR HURRICANE & SHORE PROTECTION PROJECTS**  
Honolulu Engineer District  
CEPOH-EC-T

1. Project Name: Aoa Shore Protection Project

2. Date of Inspection: April 12, 2004

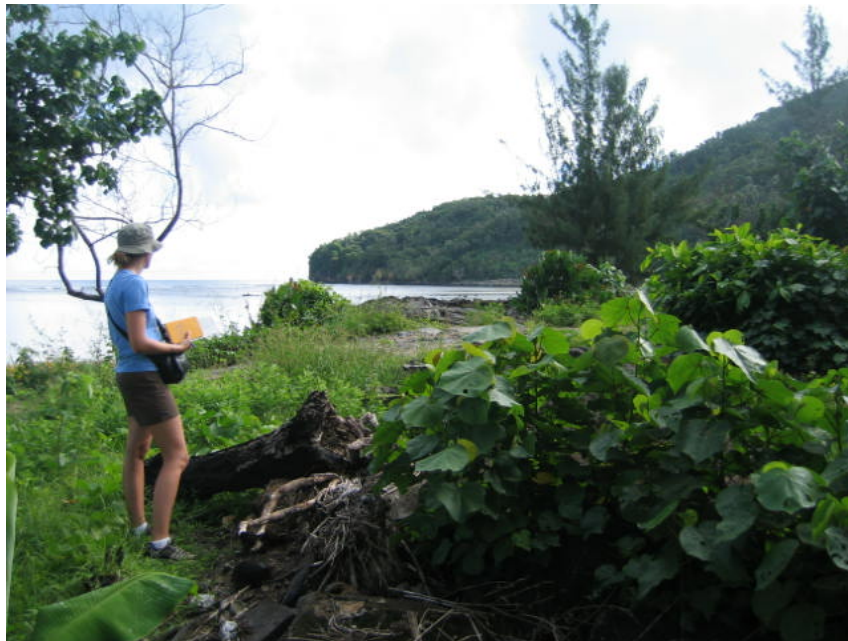
- a. Sta. 0+00, End of west tieback, in need of vegetation removal. Trees have been removed since 2003 inspection.

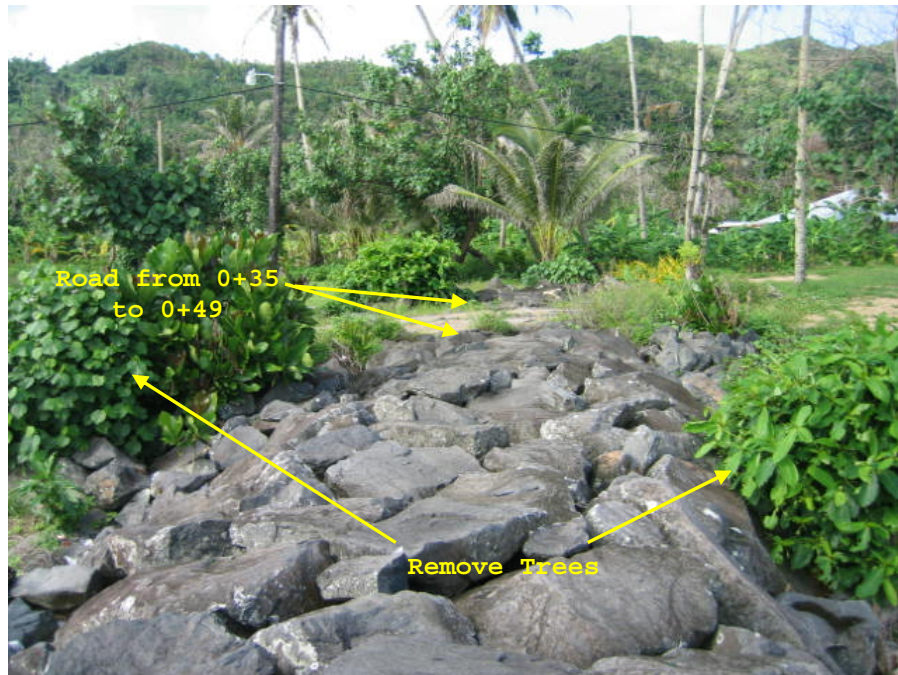
- b. Road built over the revetment from 0+35 to 0+49 by DPW. Remove tree at 0+67 interior sideslope, and at 0+70 exterior sideslope toe.

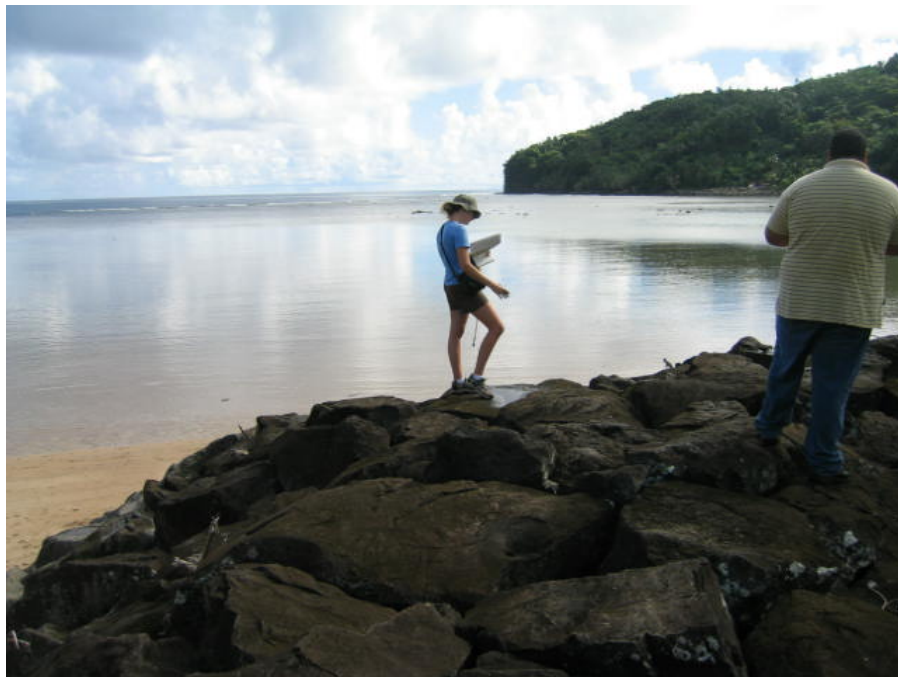
- c. Sta. 1+16, Structure alignment changes perpendicular to shoreline.

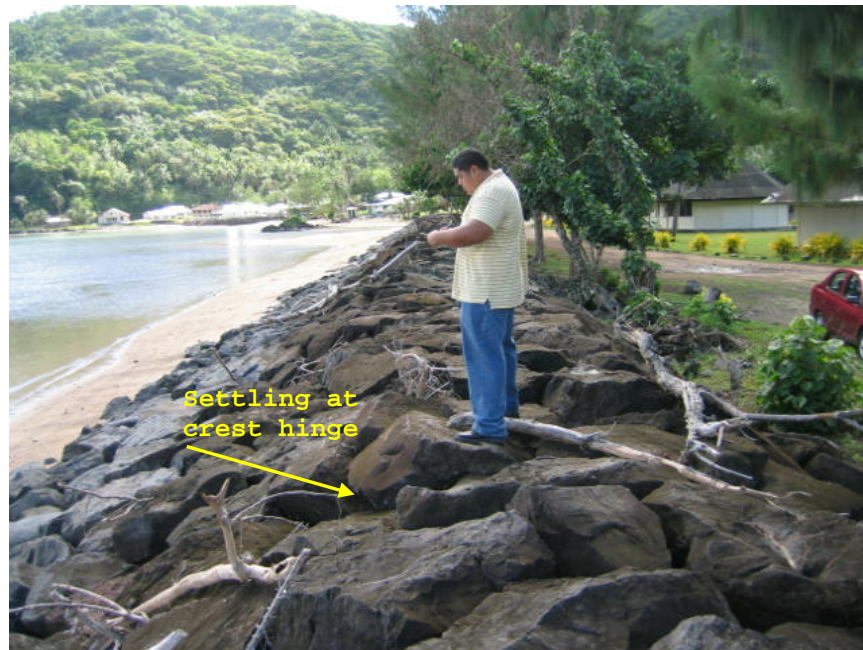
- d. Sta. 1+34, Begin area of settling and undermining. Settling at crest hinge, monitor.

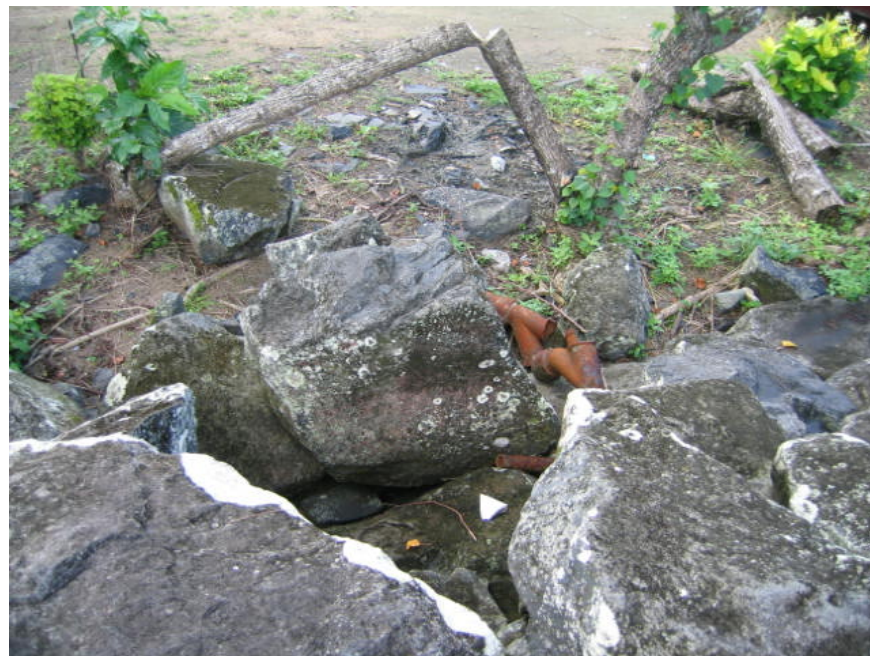
- e. Sta. 1+87, 3 ea. dislodged armor stones at the interior slope and voids. Reset stones and fill void. Remove 4 trees in area.

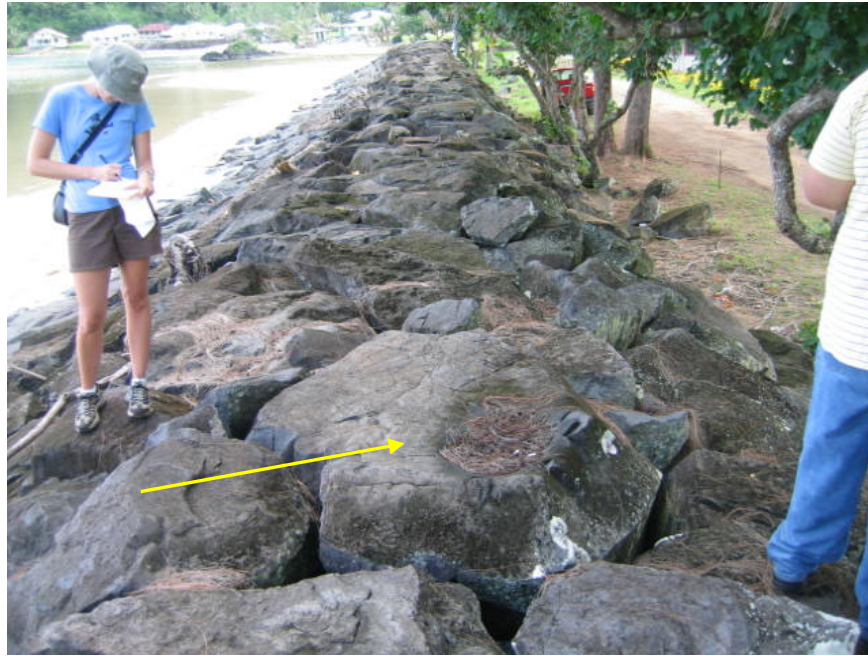
f. Sta. 2+47, Reference armor stone on centerline approx. 5 ft in length. Adjacent to restrooms.

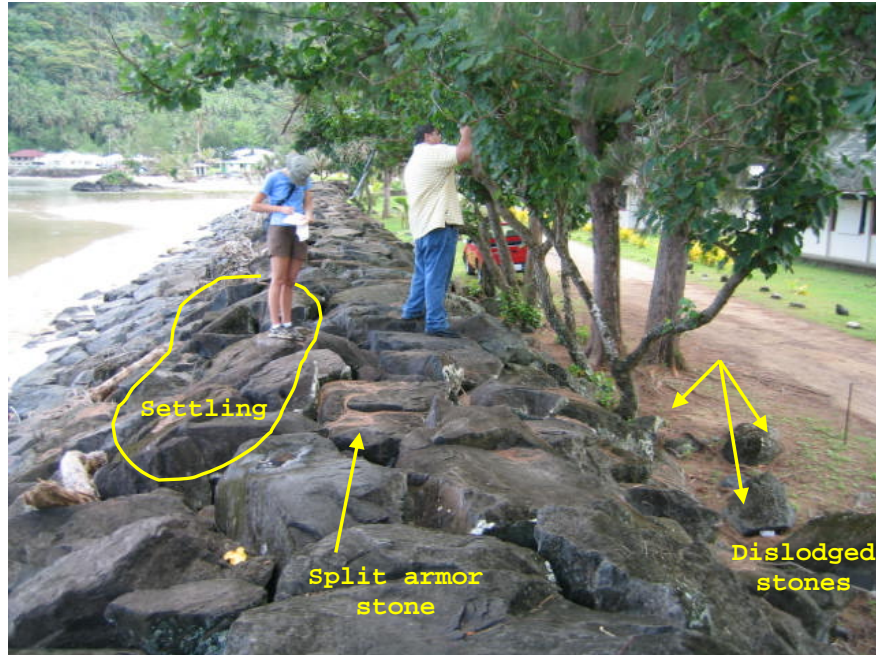
g. Sta. 2+82, Split armor stone on crest, dislodged stones on interior slope, and 10 ft area of settling on exterior slope.

h. Sta 3+07, Depression on exterior slope.

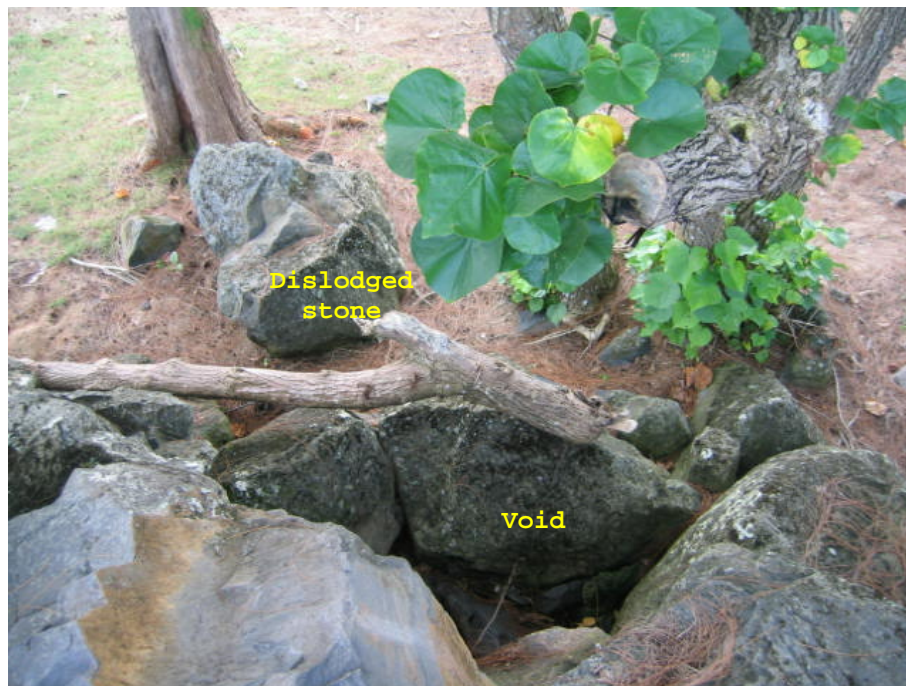
- i. Sta. 3+23, Void at interior sideslope and dislodged stone. Armor stone resting on crest (not shown).

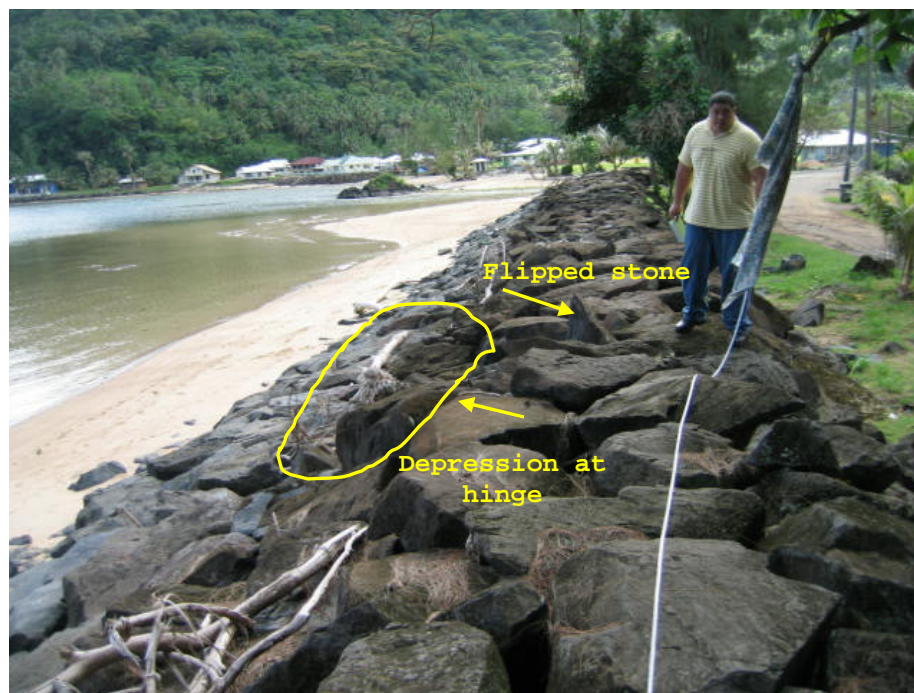
- j. Sta. 3+50, Monitor slight depression through crest and down the sideslope. Flipped stone on crest.

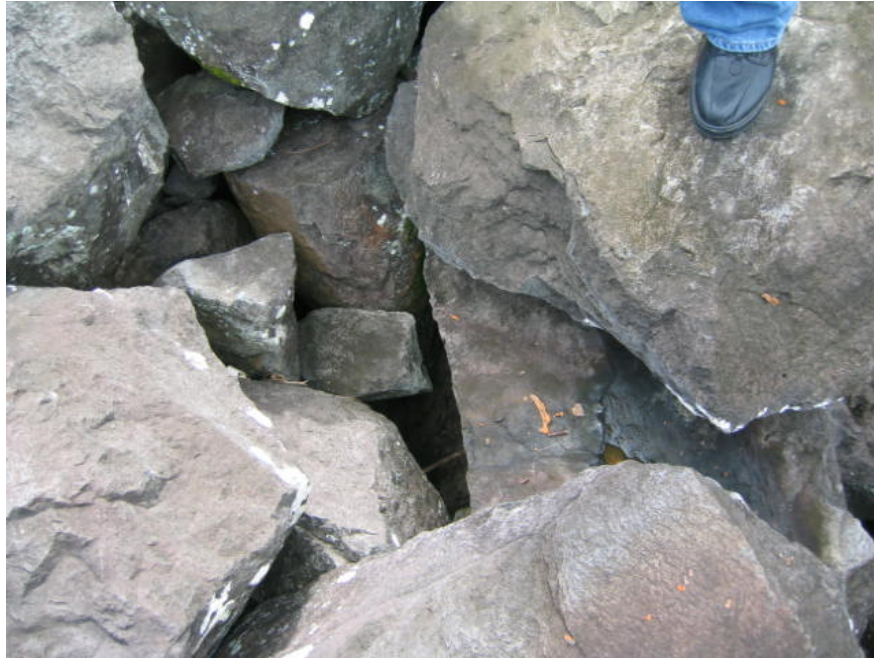
- k. Sta. 3+83, Void at centerline of crest, dislodged stone at interior toe.

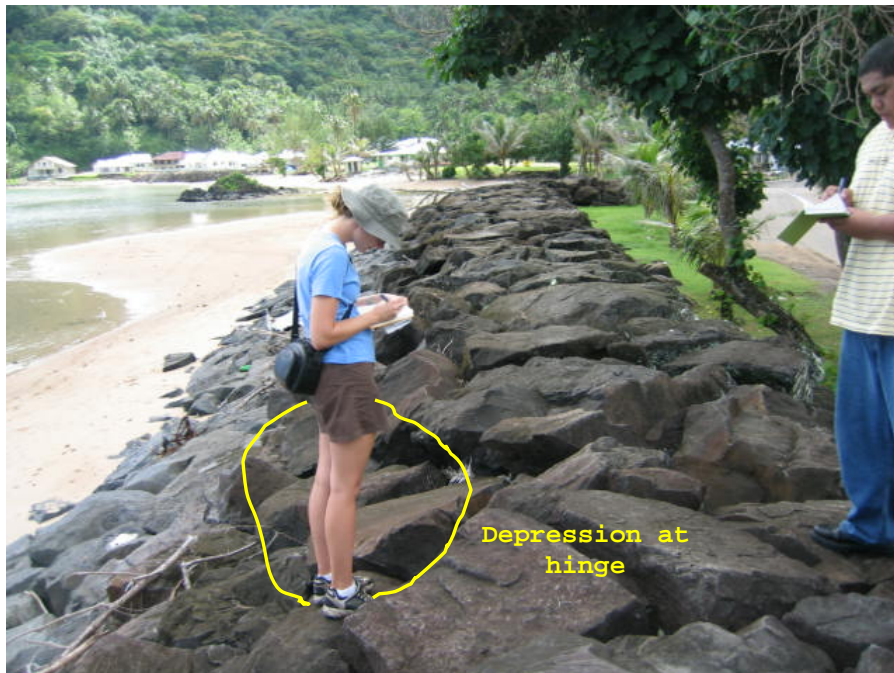
- l. Sta. 4+20, 4 ft wide depression on exterior sideslope hinge.

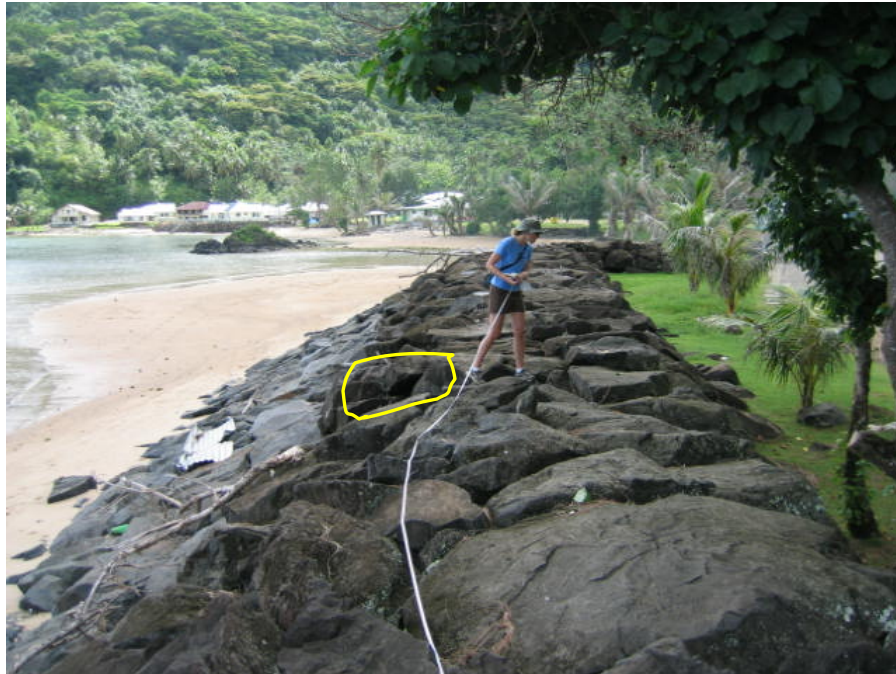
- m. Sta. 4+56, 2 ft depression on centerline and hinge of exterior sideslope.

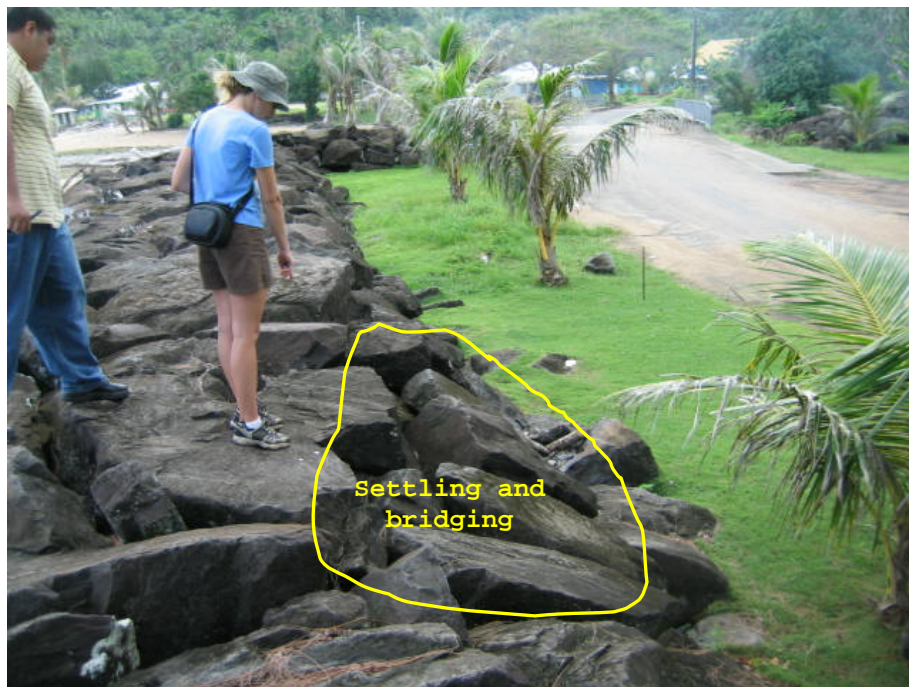
- n. Sta. 4+72, Settling at crest, settling and bridging at interior sideslope hinge.

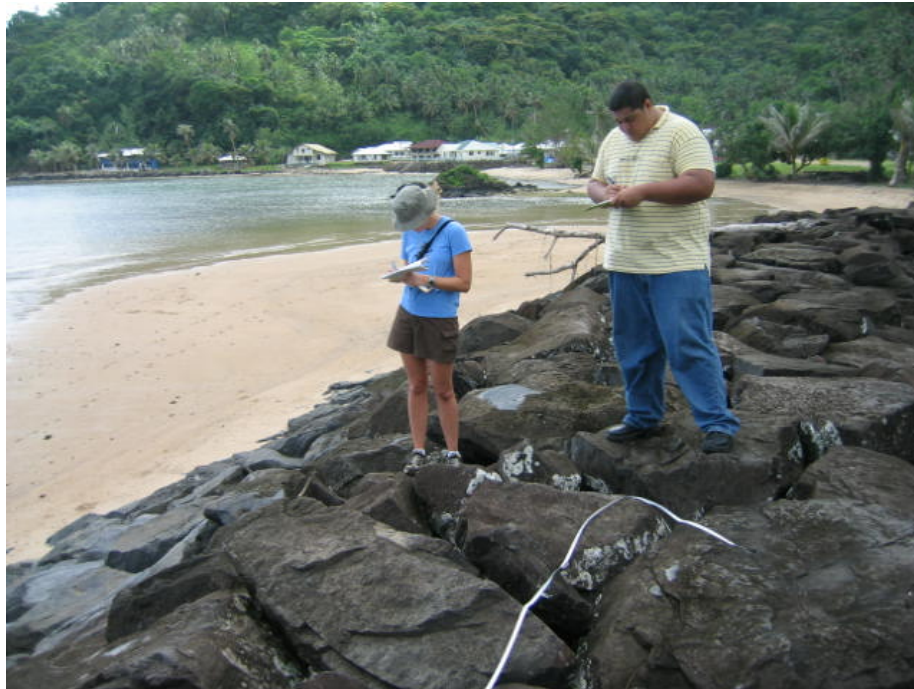
- o. Sta. 4+95, Monitor slight settling of one stone at exterior hinge (2'x2').

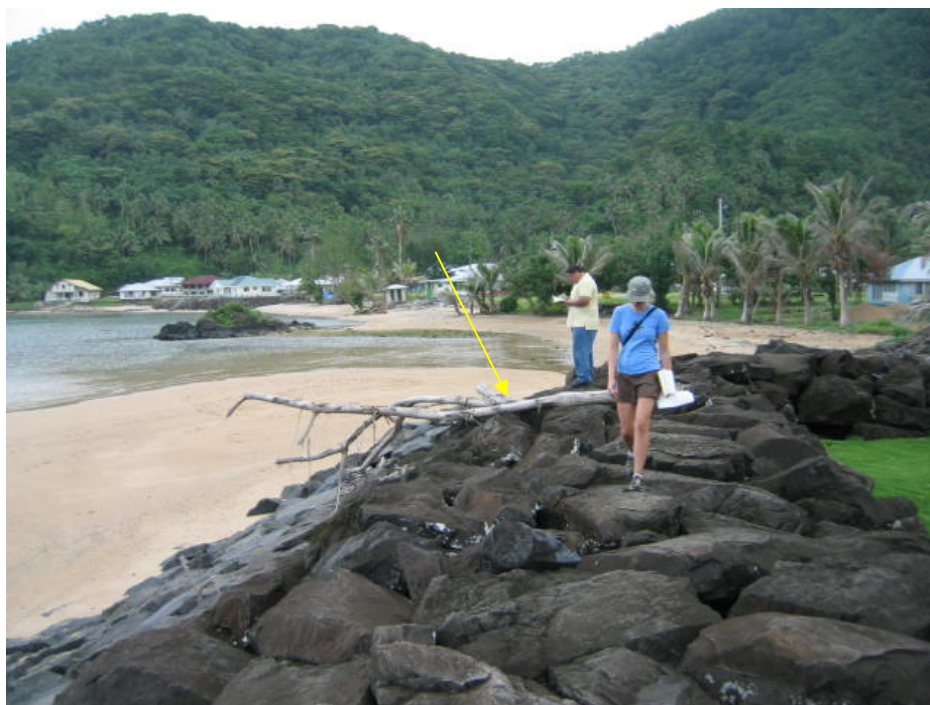
- p. Sta. 5+43, Settling of exterior sideslope at bend in structure.

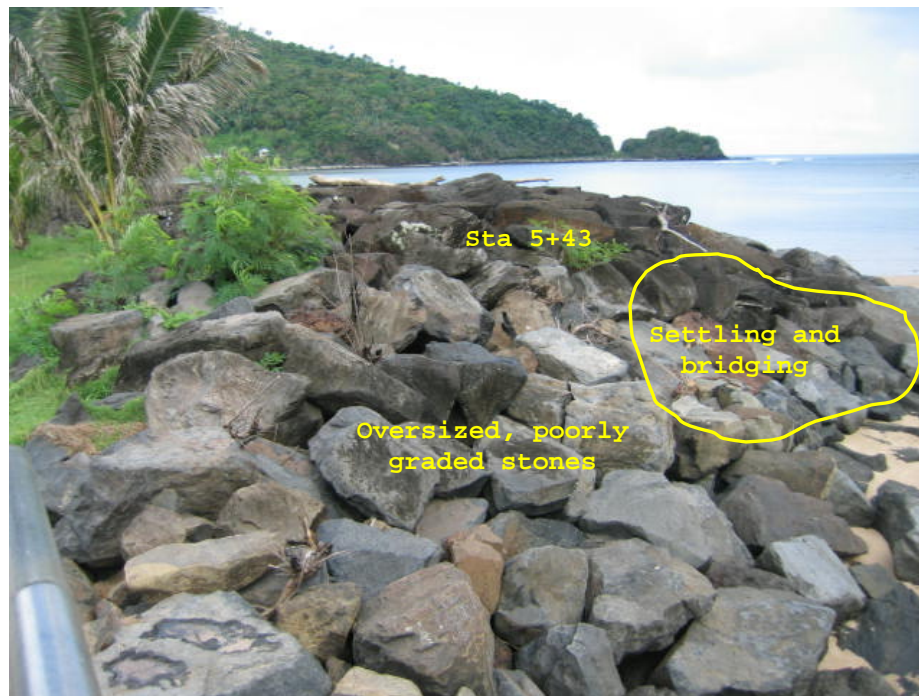
- q. Sta. 5+43, Start of bend toward road. Oversized stones and poor gradation. 15 ft area of settling.

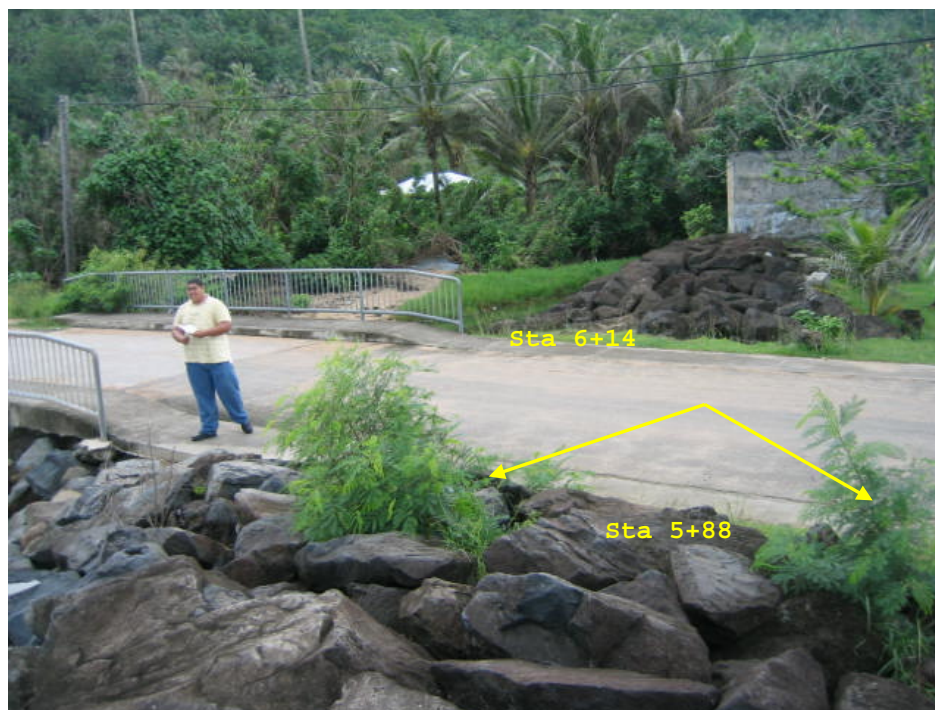
- r. Sta 5+88, Remove woody vegetation (4) adjacent to road.

Structure is primarily in good condition with respect to functionality. The focus of the maintenance required should be directed at vegetation control. Removal or herbicides are recommended in lieu of cutting.

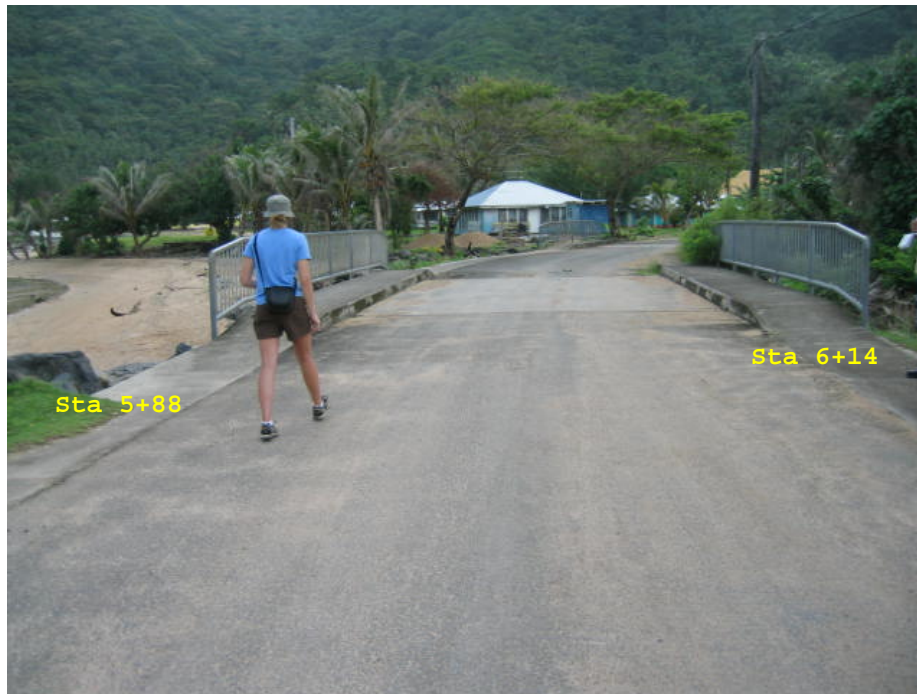
- s. Sta. 5+88 to 6+14, View of bridge/road intersecting project, facing east.

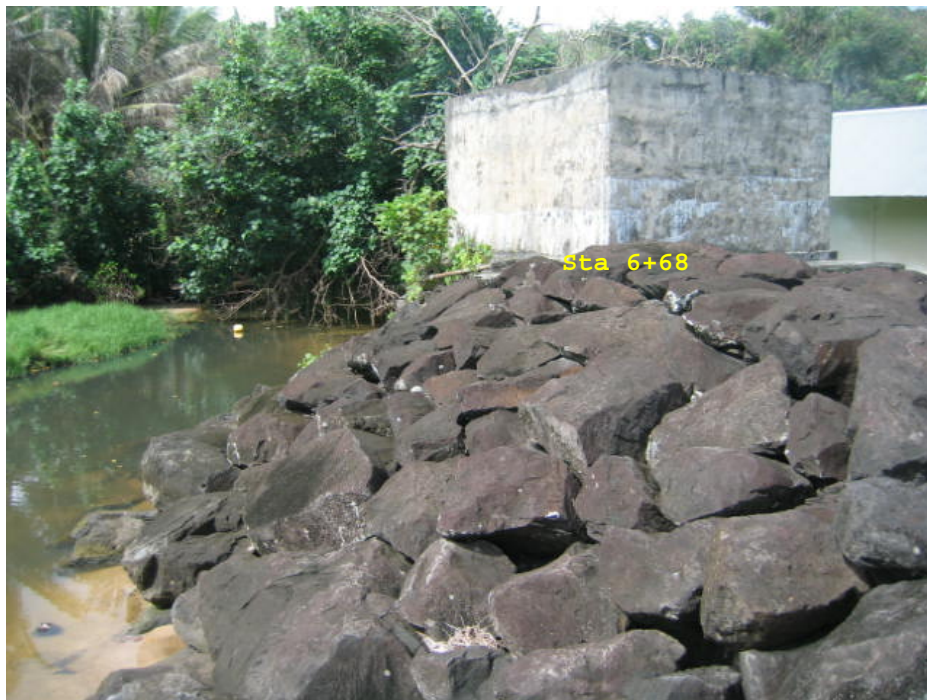
- t. Sta. 6+14 to 6+68, East tieback at interior of road. Monitor the steel sheetpiles protecting the inner tieback. Note: The sheetpile is not part of the authorized project.
